## Technical Note 135

# SmartPath™ Technology with Bridge Testing™ Verification

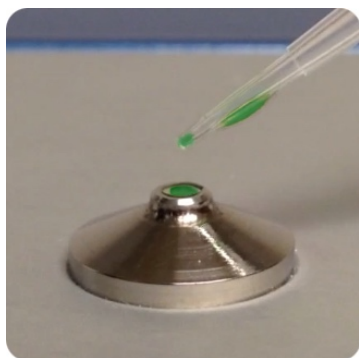
Figure 1: Example of liquid sample adhering to the side of a pipette tip, resulting in a misloaded aliquot. Green coloring was added to the sample to enhance visibility for demonstration purposes.

Sample pipetting errors can occur with surprising frequency and are often not noticed by the user. It is not uncommon to dispense significantly less than the desired sample size. The two main causes for this are (1) poorly fitting pipette tips that do not allow the plunger action of the pipettor to dispense the fluid completely and (2) samples that cling to the pipette tip instead of loading onto the sample surface (Figure 1). Purified proteins are an example of the type of samples that tend to adhere to a pipette tip rather than fully dispense onto the measurement surface.

Whatever the initial cause, the end result of a pipetting error is that less than the expected volume is delivered onto the sample measurement surface. Insufficient sample volumes can result in an unbridged condition on some spectrophotometers and produce erroneous measurement data. In many cases, the user will not realize reported sample concentrations are incorrect on these instruments because there is no indication that an unbridged measurement has taken place.

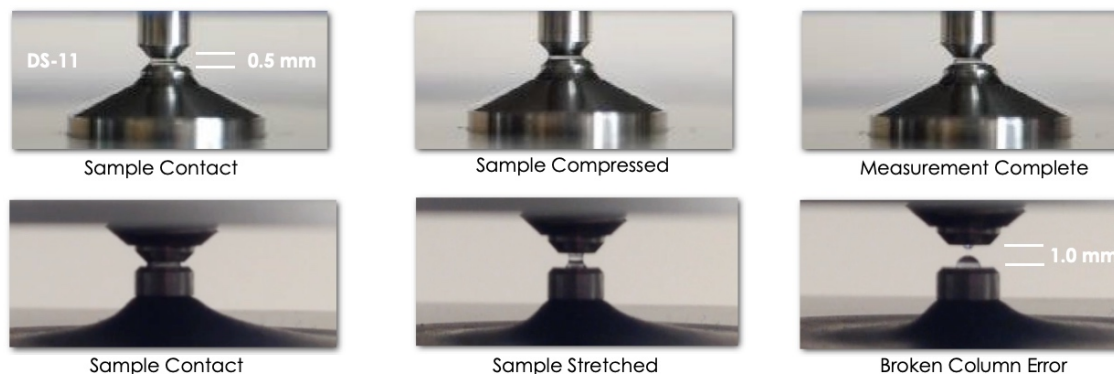
Figure 3: The DS-11(top row) contacts and maintains the liquid bridge between measurement surfaces throughout the entire measurement cycle. The initial liquid bridge may break under the same measurement conditions on a competitor's instrument (bottom row.)

DS-11 and DS-8X instruments use a 0.5 mm path and compresses a sample during measurements, giving them an inherent advantage over other microvolume spectrophotometers that use a 1.0 mm path. Other spectrophotometers must stretch the sample to bridge the 1.0 mm gap. Making a measurement with an unbridged sample due to unconditioned surfaces or after a pipetting misload can lead to erroneous results when using instruments that rely on stretching the sample.
